FUNCION TEST REPORT

Project No.:TL17-70003

Equipment under Test: Close RELAY

Model/Type : ECA042-H
S/N : AUX112151

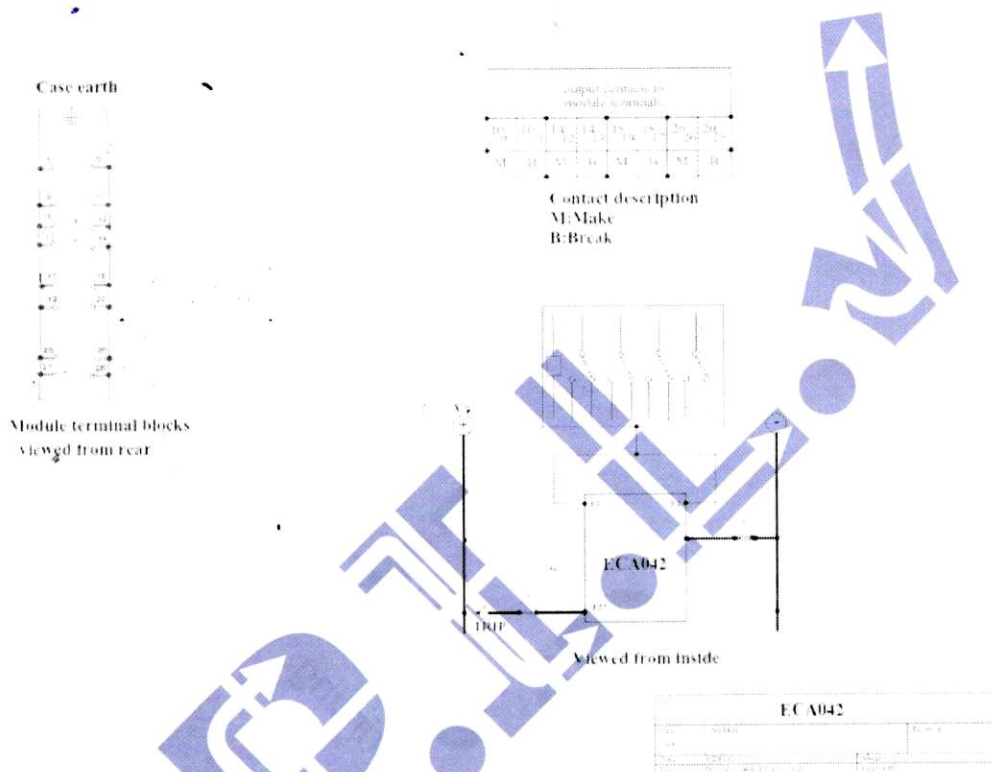
FIGURE 1 : EUT connections and terminals

The functions of heavy duty self-reset relay shall be tested. Tests shall be conducted to demonstrate the operation time and disconnection current of the discussed relay during the Operation voltage range (52 to 140 VDC). The different between the time of occurring the Trip and Operation of relay contacts according to Fig 1 shall be measured as operation time.

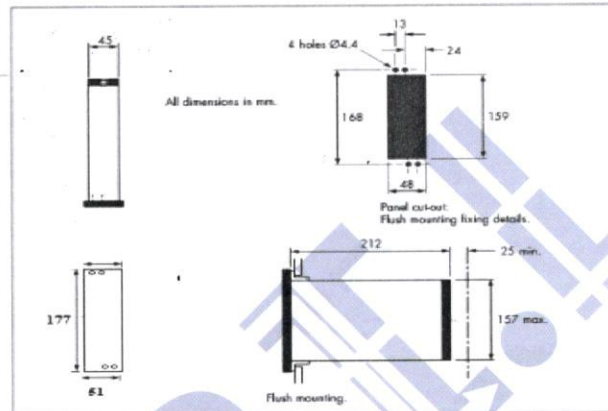
Figure 2 : Drawing And dimensions of EUT

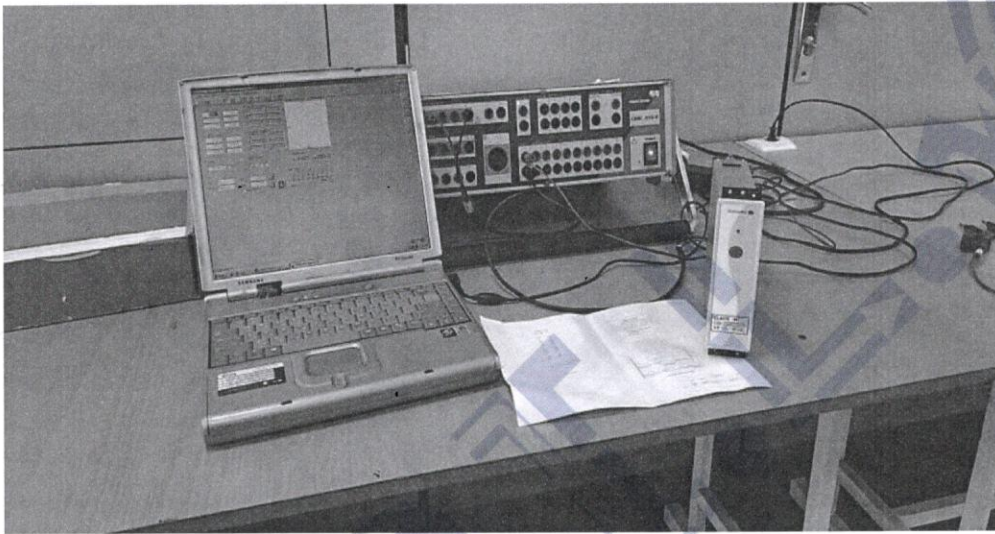
Figure 3 : The test circuit of measurement of operation time of EUT.
